# SPECIAL INSTRUCTION

## Cylinder Block Salvage Procedure Using Belzona® Ceramic R Metal

005  
1201

### Cast Iron Cylinder Blocks

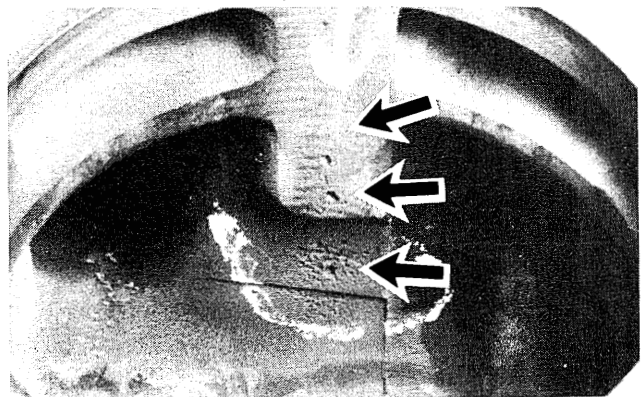
Pitting in sidewall of cylinder block.

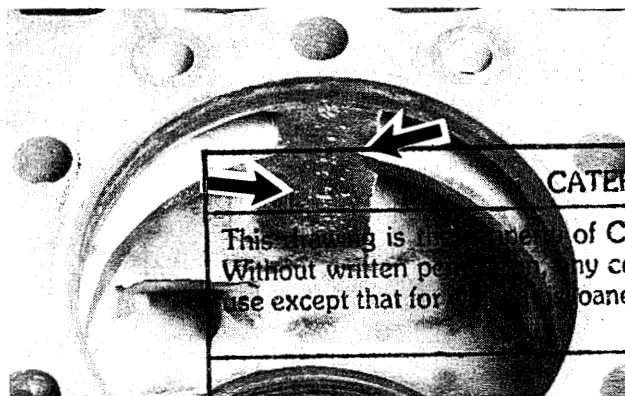
Pitting in cylinder bore (head bolt boss).

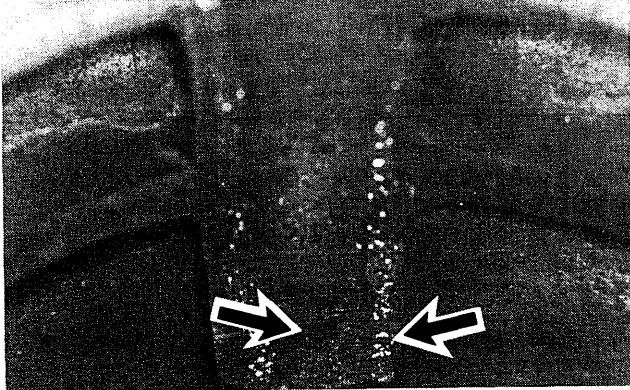
Deep pitting within cylinder liner bore.

**1.** If the eroded area has deep pitting, as shown above, all corrosion must be removed from the pitted area. This can be done manually by using an ice pick, or by using an air powered needle scaler.

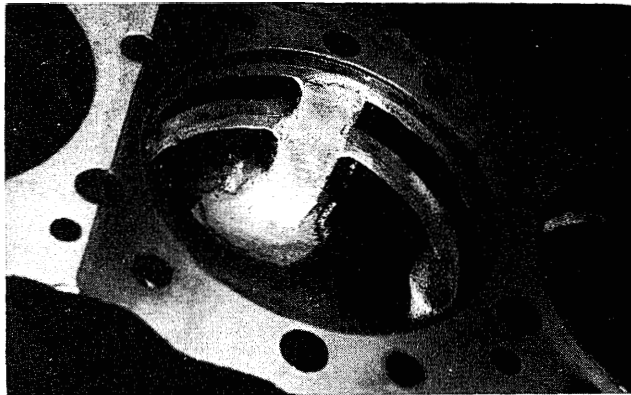
Repaired area after finish grind of repair material.

4. Approximately two hours after the repair material has been applied, it should be hard enough for the finish grind. In those areas where there are close clearances, grind away enough material to get the piece part back to its original dimension(s). Other areas should be left with a slight build-up of the repair material for resistance to future erosion.
